2. Analysis

The two flight crewmembers of Gulf Air Flight GF-072 were properly certificated and qualified in accordance with applicable civil aviation regulations of the Directorate General of Civil Aviation and Meteorology (DGCAM), Sultanate of Oman, ICAO standards and Gulf Air company requirements. There was no evidence to indicate that the performance of either member of the flight crew was affected by any medical factors.

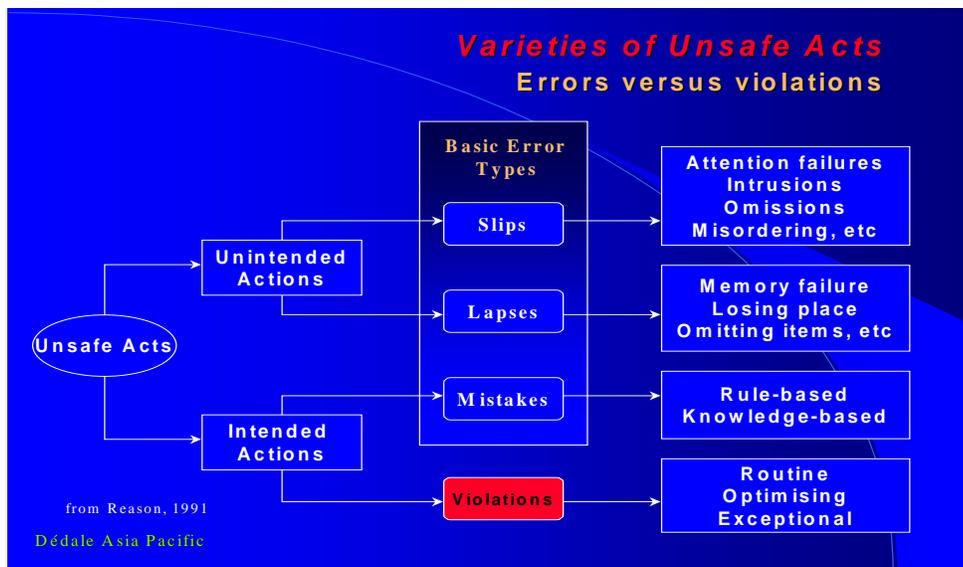
The Reason Model uses the term ‘unsafe acts’ to refer to decisions or actions which have an immediate effect on the safety of the operation. Unsafe acts can be further categorised in terms of ‘intended’ and ‘unintended’ actions. Intended actions can be either mistakes, or violations (see Figure 10).

Figure 10: Varieties of Unsafe Acts

In the accident to GF-072, a number of SOPs were violated by the captain (refer to sections 2.4 and 2.5). These non-standard actions appeared to have involved a combination of factors described in unsafe acts (see section 2.5.3). For example, when the first approach unexpectedly turned out to be unsuccessful, the captain attempted to solve the problem by taking an ad hoc decision to execute a non-standard and unplanned manoeuvre (an orbit). This was a course of intended action, which involved poor judgement, non-adherence to SOP's, and in Hudson's terms an '*exceptional*' violation. It was an 'unsafe act' as described in section 2.5.3, which had an immediate adverse effect upon the safety of the system. The captain performed this unsafe act without prior briefing to his first officer, and in the absence of any valid operational necessity, such as an unexpected emergency.
